Longford Village Hall  
Longford Lane, Gloucester  
GL2 9EL

## Condition Report

20255/October 2016

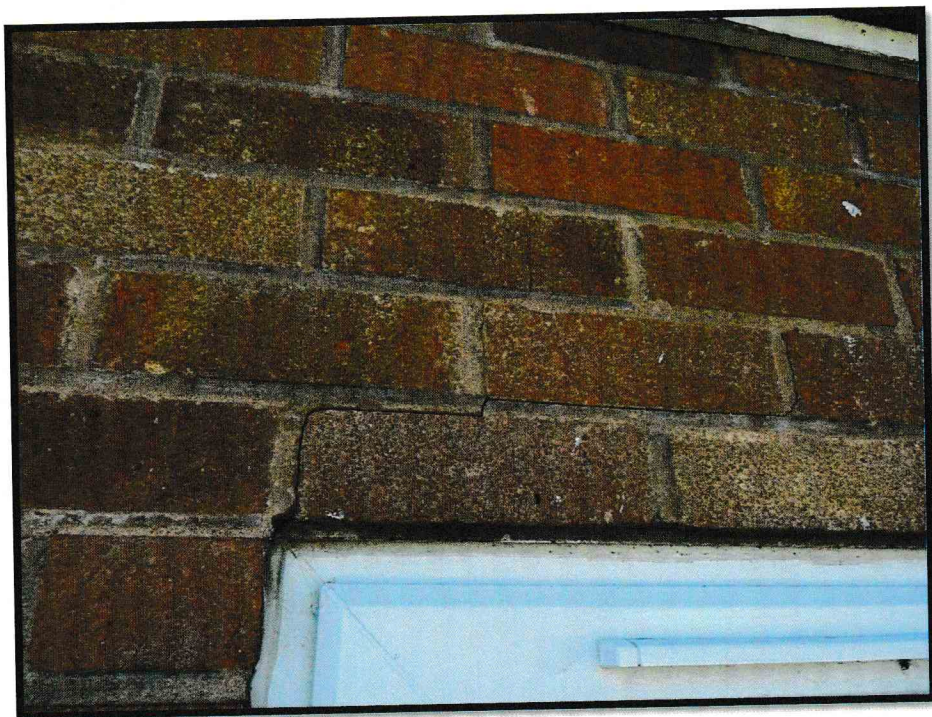
Walls are constructed in sand faced clay facing bricks above DPC. The external finish appeared to be in good order and only one small settlement crack was noted to the left hand end of the kitchen window lintel, presumably as a result of the previous window replacement (fig. 01).

Fig. 01. Minor settlement crack above window lintel

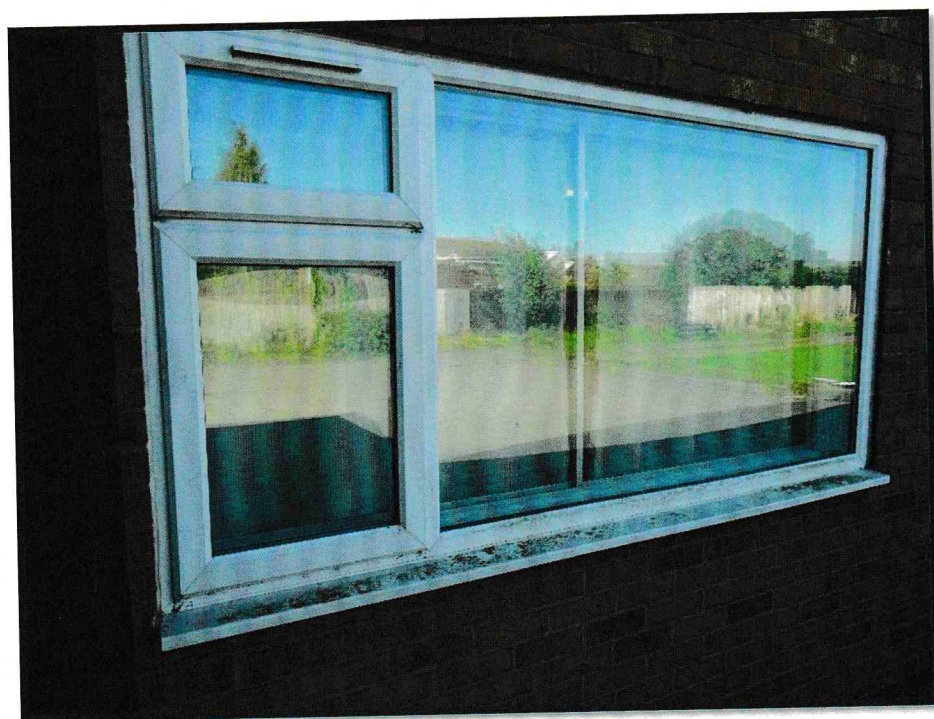
Fig. 02. Existing windows require minor cleaning

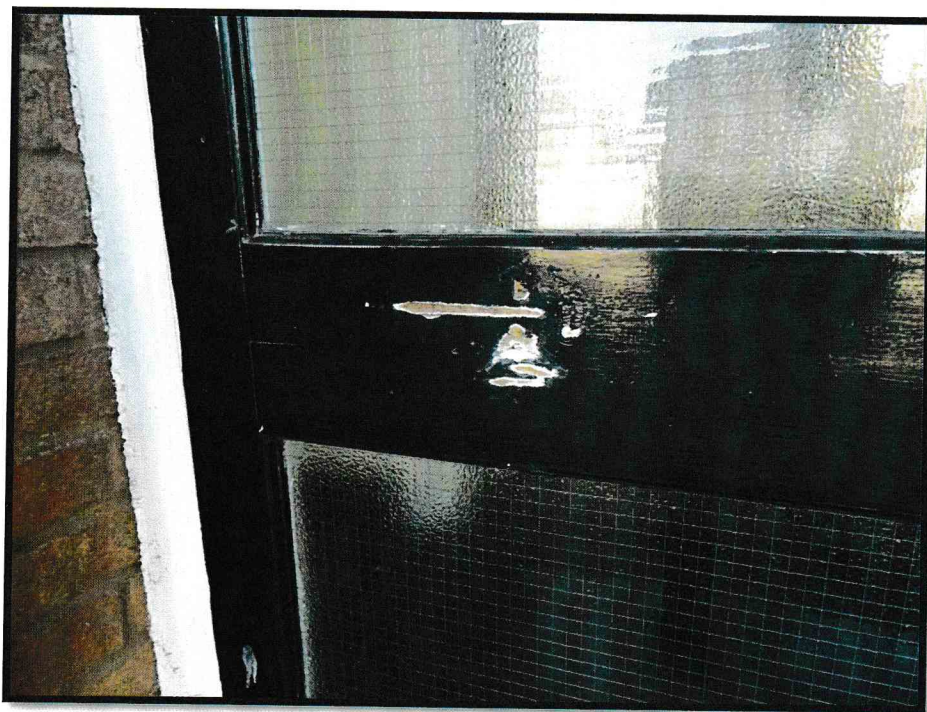
The main entrance doors are single safety glazed, timber framed doors. These are in reasonable condition although would benefit from redecoration and the ironmongery was noted as being worn (fig. 03).

Fig. 03. Main entrance doors require redecoration

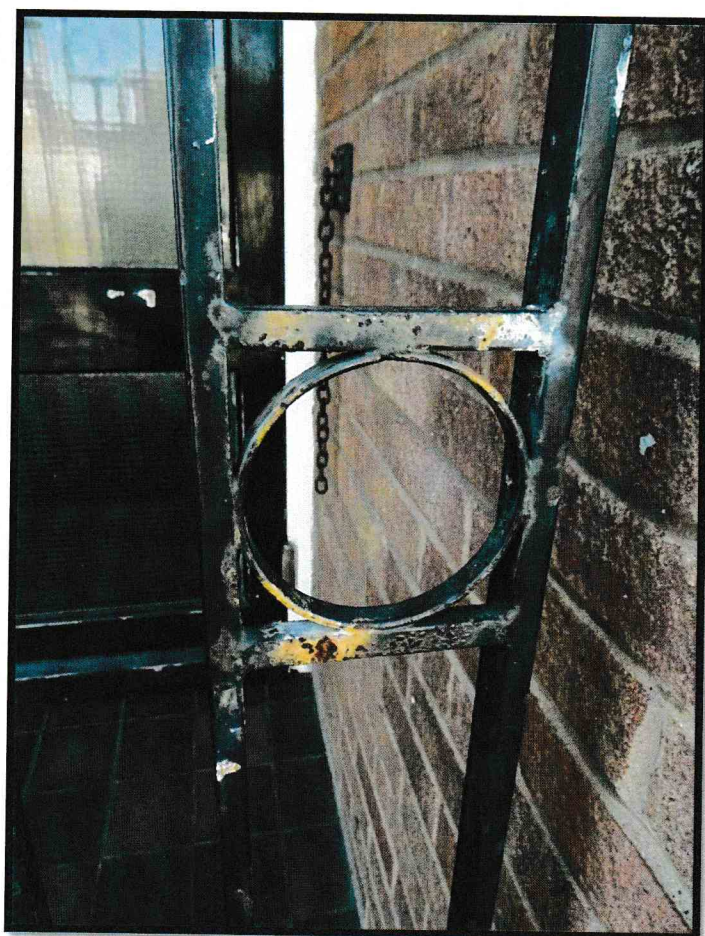
A pair of black metal gates are fixed within the entrance reveals. Again, these are in reasonable condition, some areas of peeling paint and corrosion were evident and these would benefit from treatment and re-coating to arrest the development of the corrosion (fig. 04).

Fig. 04. Front gates require attention

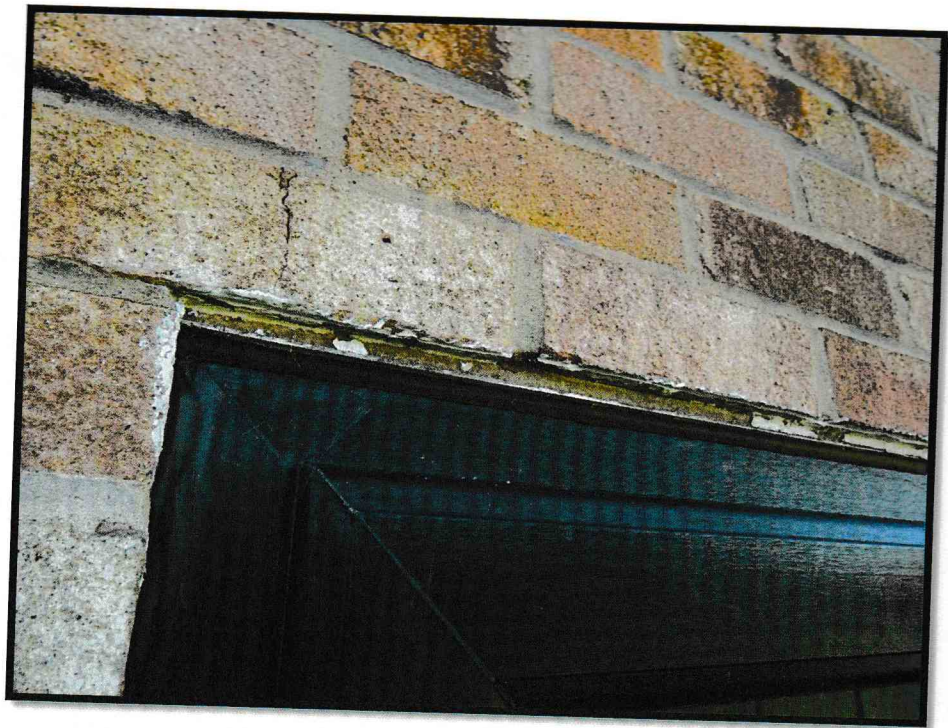
A pair of brown uPVC double doors leads from the main hall and these appeared to be in good condition. A small amount of pointing/caulking is required at the head to seal to the face of the lintel (fig. 05).

Fig. 05. External door head requires minor making good

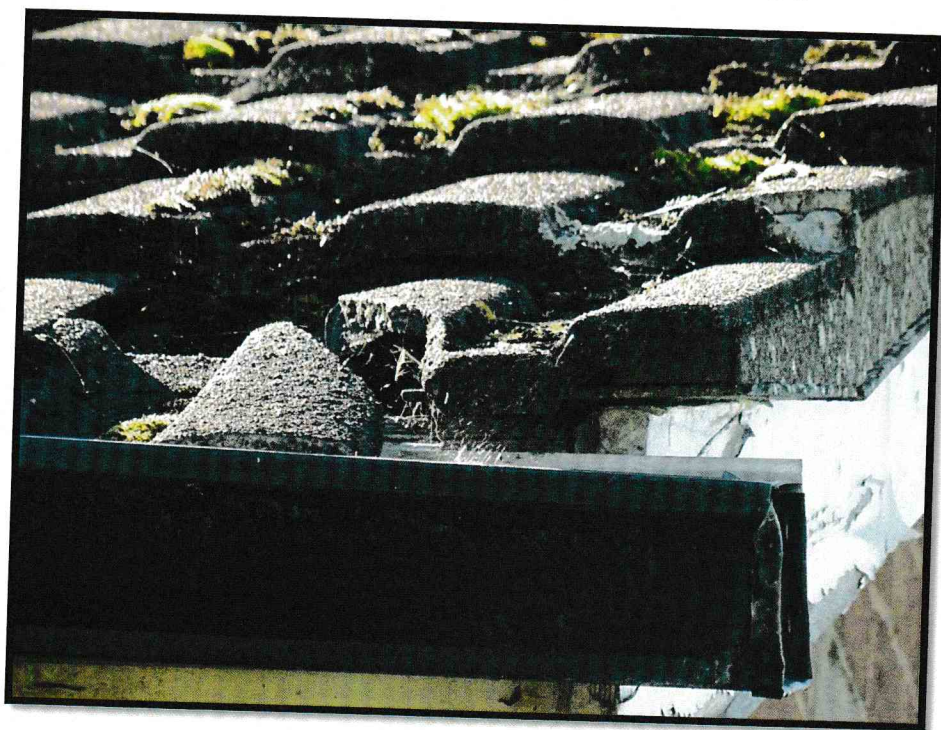
The main hall features a pitched roof of concrete tiles (possibly Redland Renown or similar). The tiling appears to be in good order except for the lower right hand corner where a number of tiles are damaged (fig. 06). This is resulting in water ingress which has damaged the fascia, soffit and barge board to the return (fig. 07). The underlying timbers should be checked as part of the repair.

Fig. 06. Roof tiling requires urgent repair

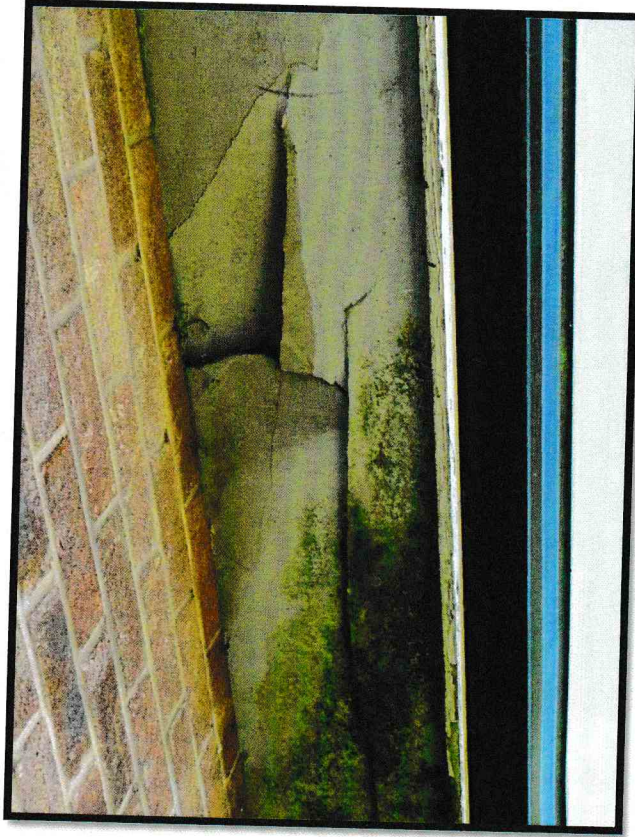
The soffit appears to be a form of cement board. The soffit is damaged to the right hand end of the hall and requires replacement (fig. 09). The soffit board material should be tested for asbestos content prior to any remedial works being undertaken.

Fig. 09. Damaged soffit

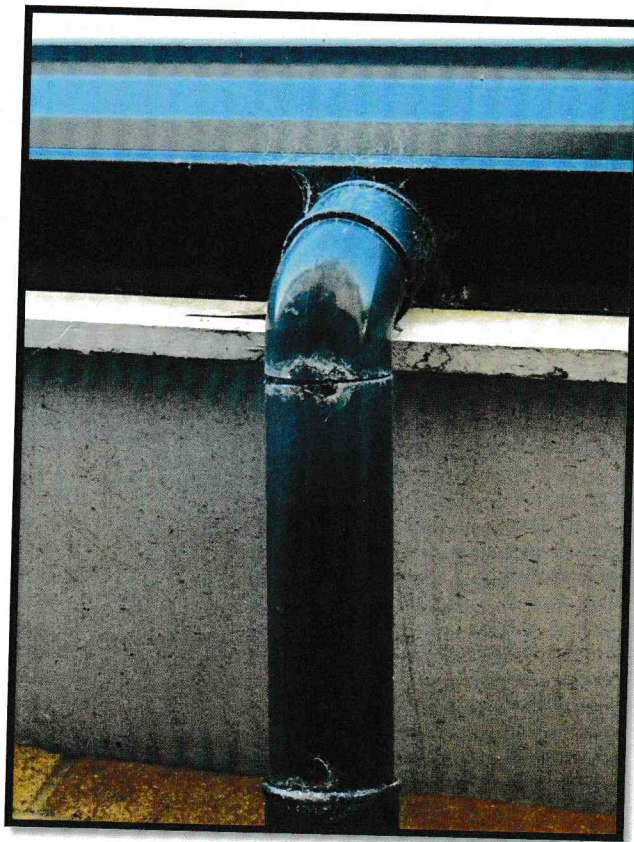
Fig. 10. Rainwater pipe joints starting to leak slightly

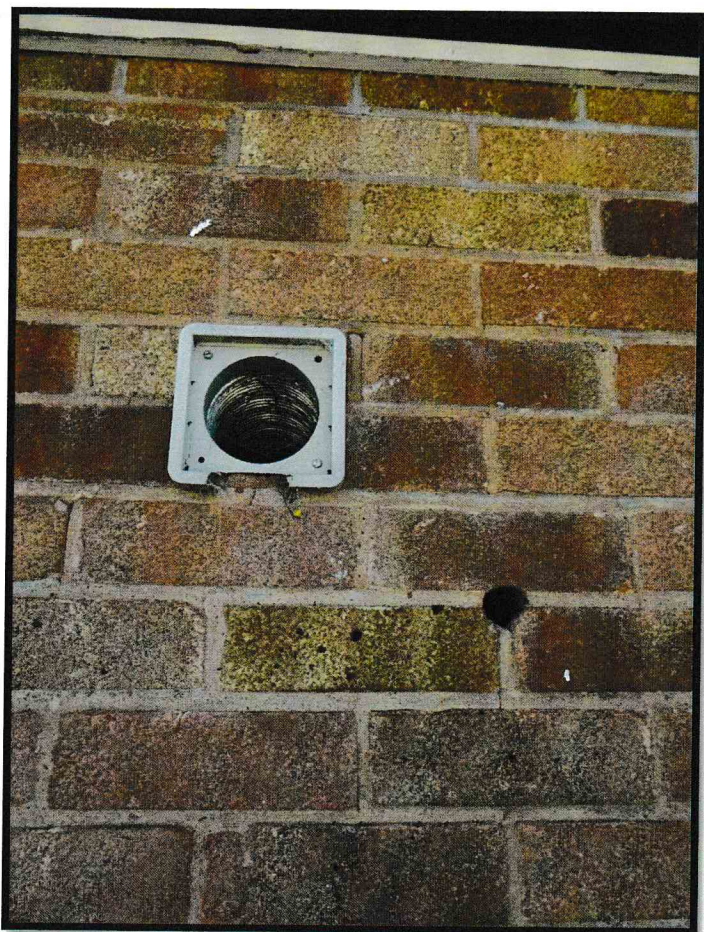
The extract fan from the ladies WC is missing its external cover and requires replacement. There is also a hole through the wall to the right of this which should be filled (fig. 11).

Fig. 11. Extract requiring grille and hole requiring making good

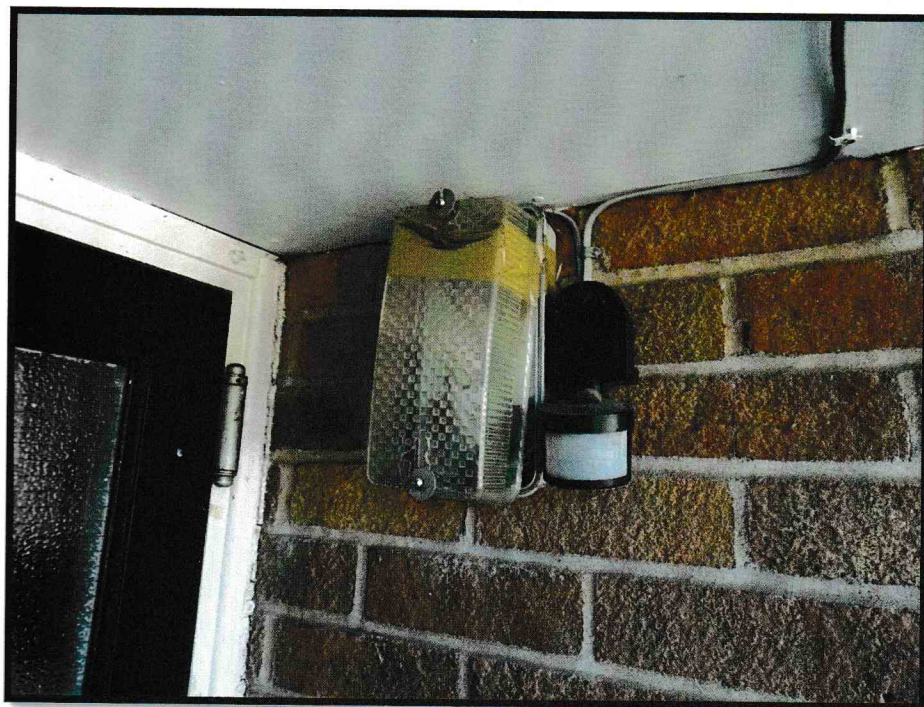
The bulkhead luminaire in the porch is broken and should be replaced (fig. 12). Other luminaires were present and operational although the fittings/lamps are clearly aged.

Fig. 12. Damaged external lobby light fitting

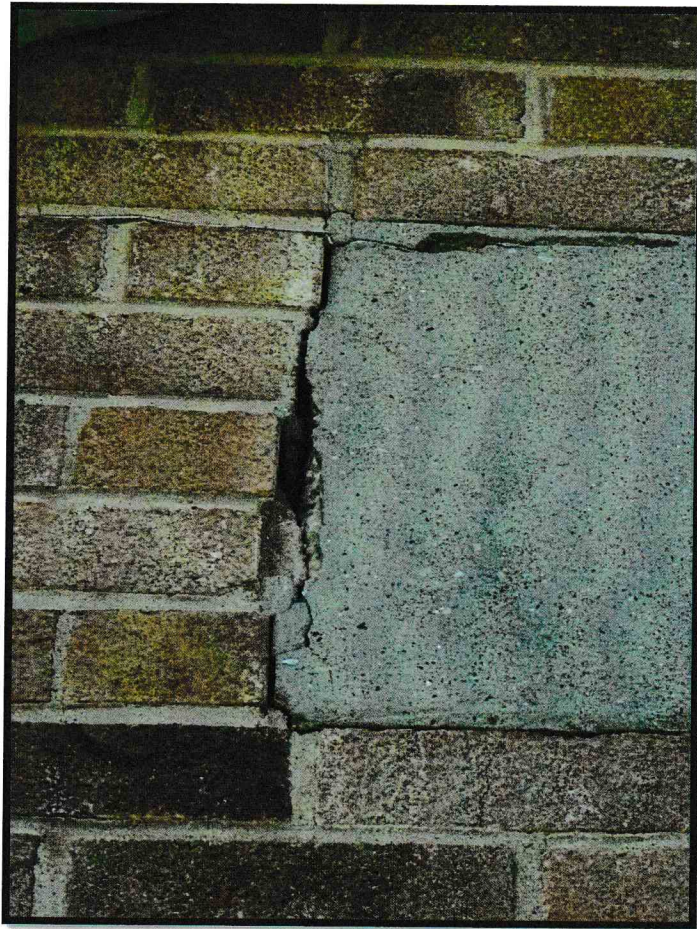
The walls are constructed in sand faced clay facing bricks which are in good condition. A concrete lintel is built in to the wall to enable future expansion. The face of the lintel appears to be sound, there is slight settlement cracking/missing pointing to the left hand end (fig. 13).

Fig. 13. Slight settlement cracking to lintel

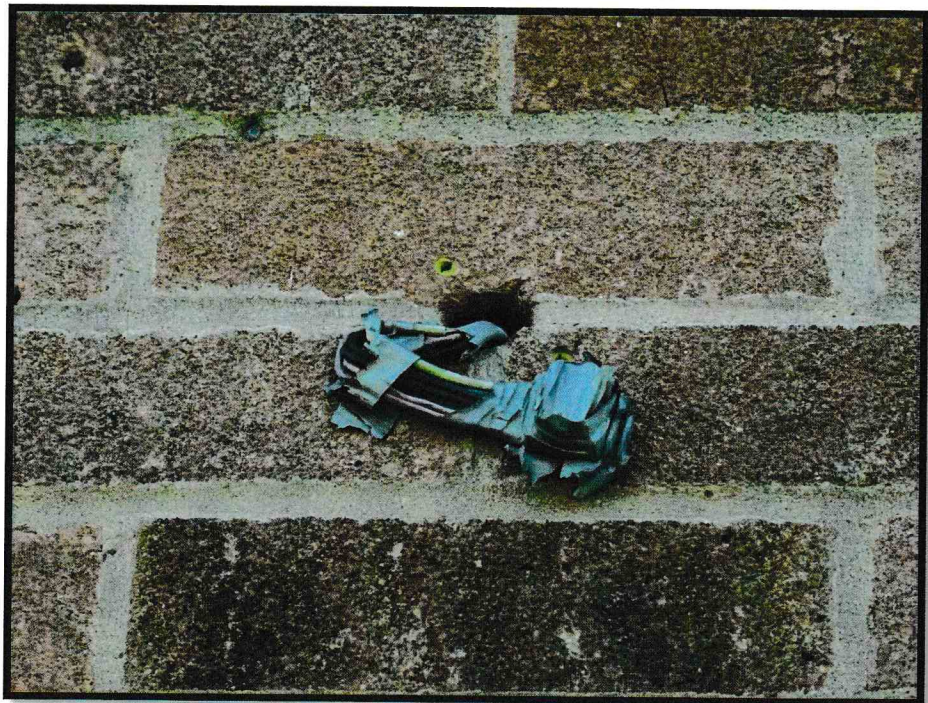
Fig. 14. Cables requiring proper termination

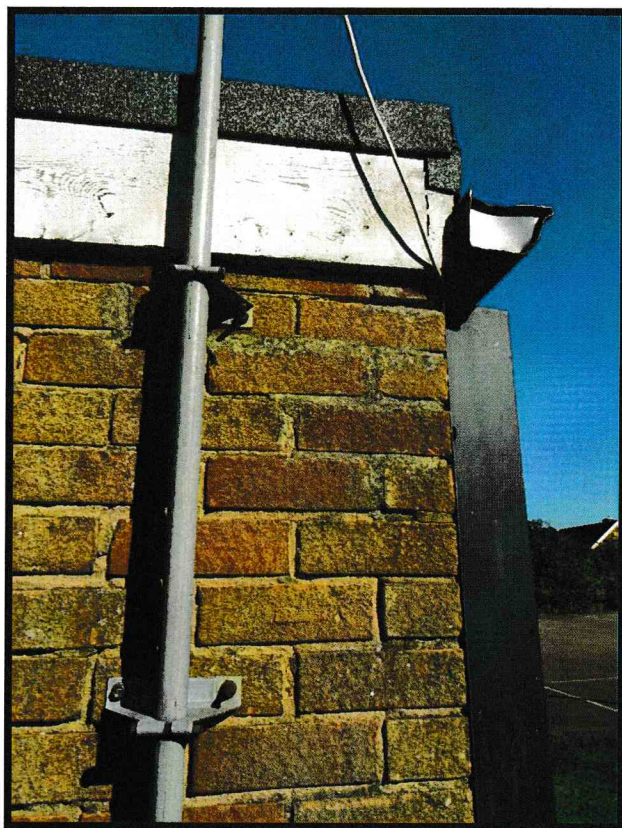
Fig. 15. Minor cracking on the mortar joints to the external corner

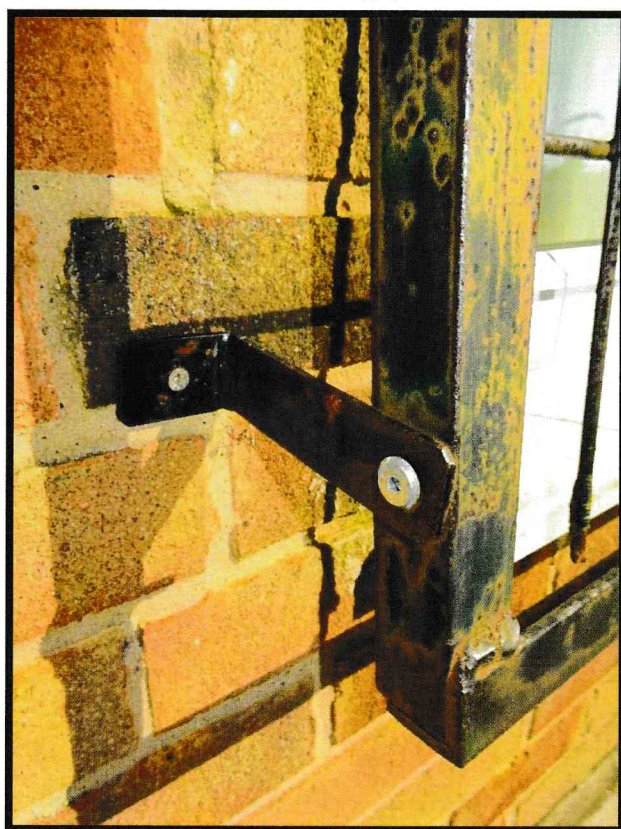
The windows have steel grilles fixed over them. In places the mesh welds have split and the frame fixings are missing or loose in a number of locations. The grille and frame are also suffering from general surface corrosion (fig. 16).

Fig. 16. Loose fixings and dilapidation of the window grilles

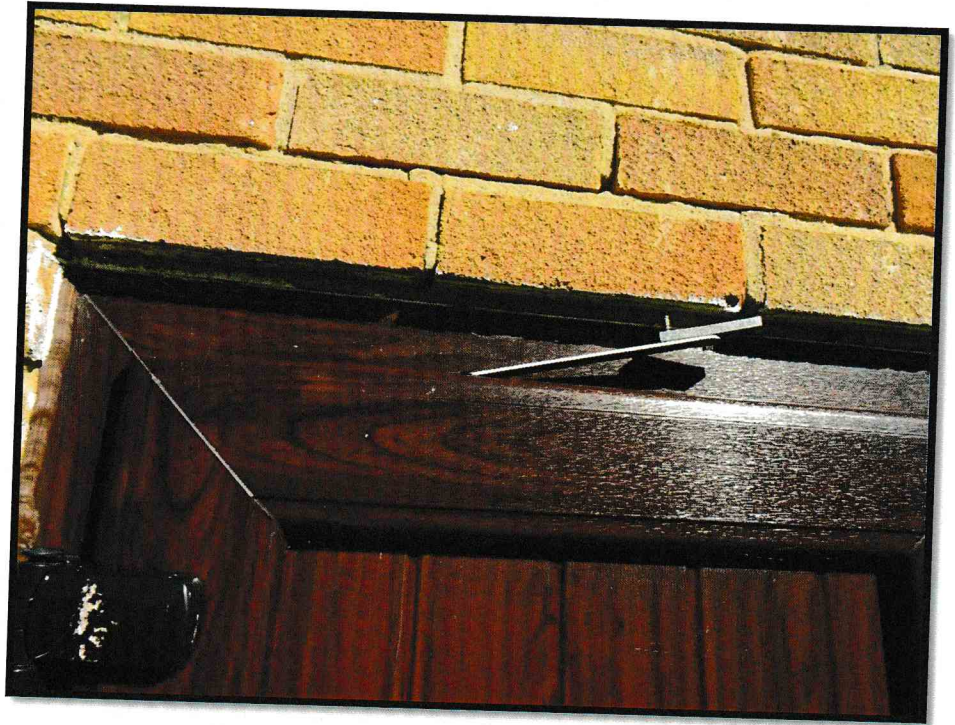
There are two sets of uPVC double doors which both appeared to be in good order. The left hand set have a broken closer to the left hand leaf and this is now projecting externally which is also causing the door to not close properly. This should be fixed to prevent further damage to the door, frame or hinges (fig. 17).

There are three sets of uPVC double doors from the hall which are all in good order. The right hand rear doors have a broken closer and the arm is projecting externally (fig. 17). This should be addressed to prevent further damage to the door and frame.

Fig. 17. Damaged door closer arm requires attention

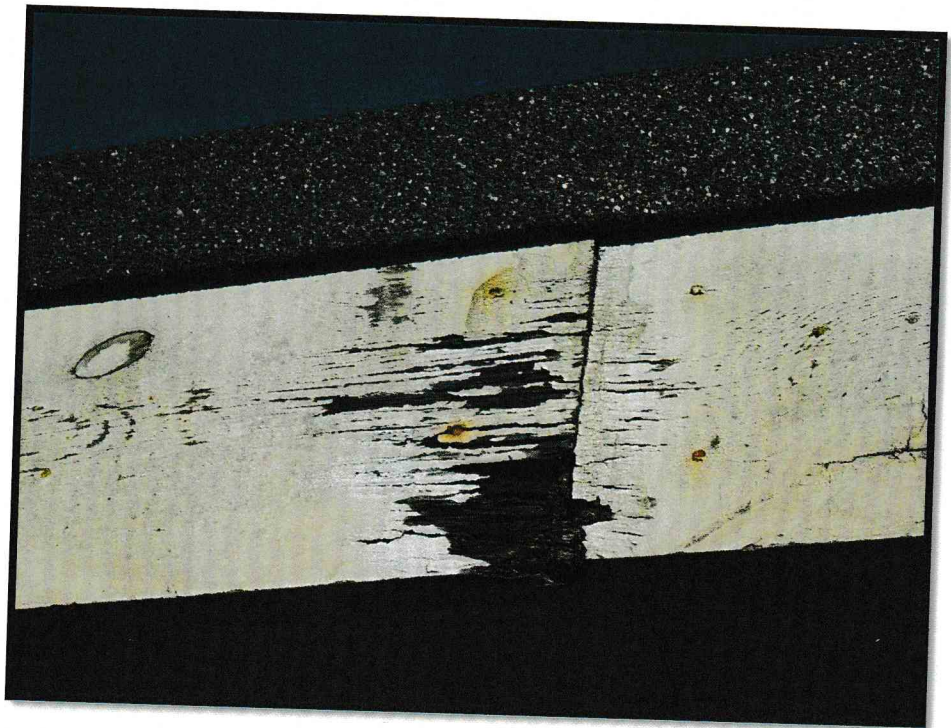
The fascia boards both to the hall and lower changing room areas are gloss painted timber and are showing signs of rot to the bottom edges in places (fig. 18).

Fig. 18. Further rotting to the fascia boards to the rear of the building

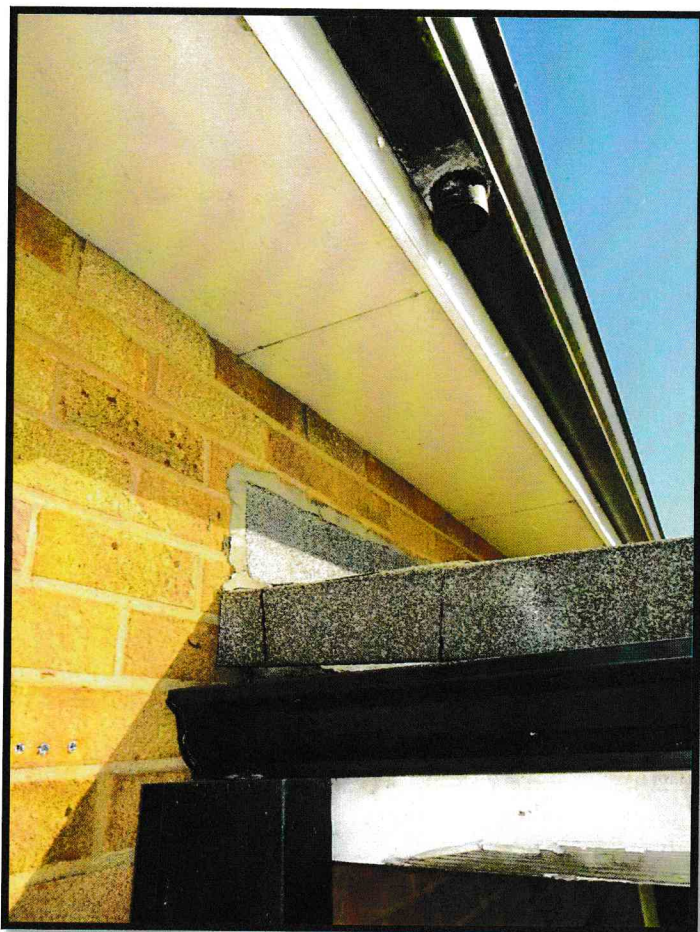
Gutters are installed in uPVC and appeared to be in good order. A number of areas would benefit from light cleaning. A section of downpipe was missing above the canopy area (fig. 19).

Fig. 19. Down pipe missing

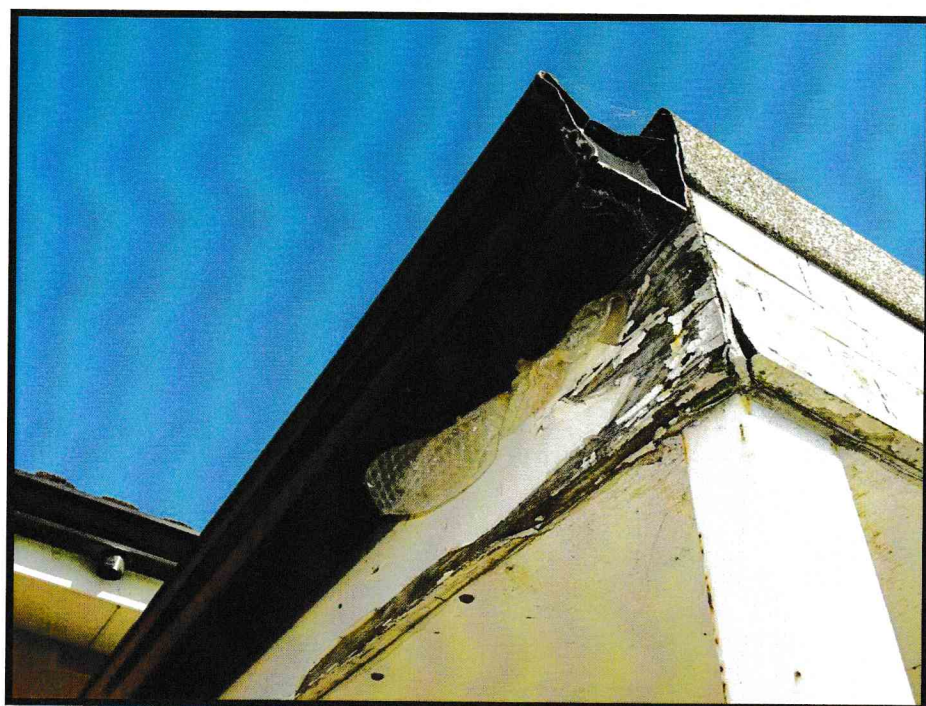
An external canopy, supported via a steel post abuts the hall and changing room areas. The outside corner appeared visually to possibly have dropped slightly and there are signs that it could have been repaired previously. The fascia was showing signs of rot generally and some bubble wrap appeared to possibly be filling a hole to the rear of the gutter (fig. 20). The steel post base is showing signs of surface corrosion (fig. 21).

Fig. 20. Damaged fascia to the external canopy at the rear

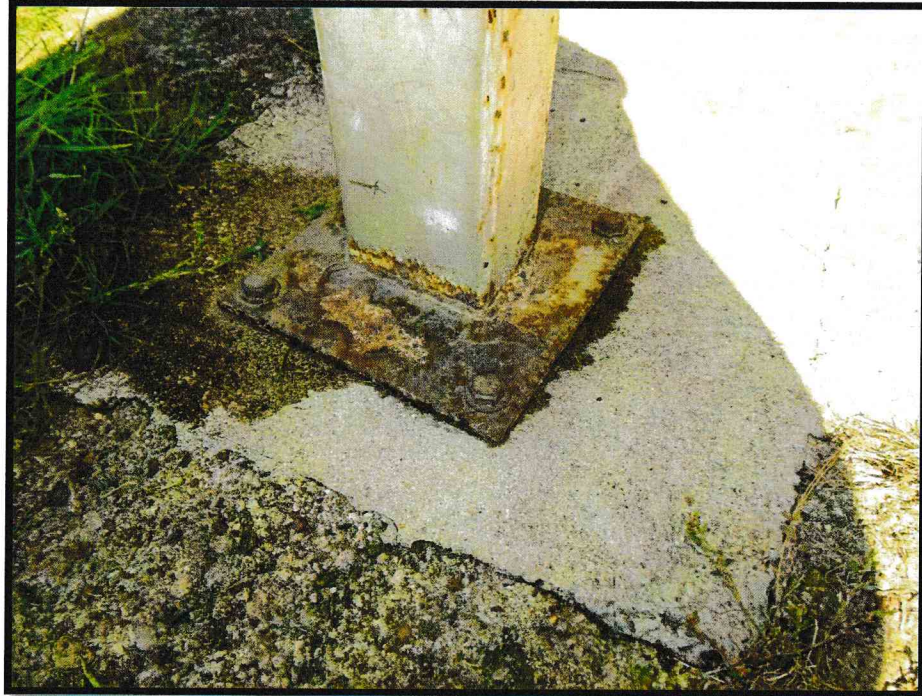
Fig. 21. Corroded canopy post foot, water on ground suggests gutter stop end leaking

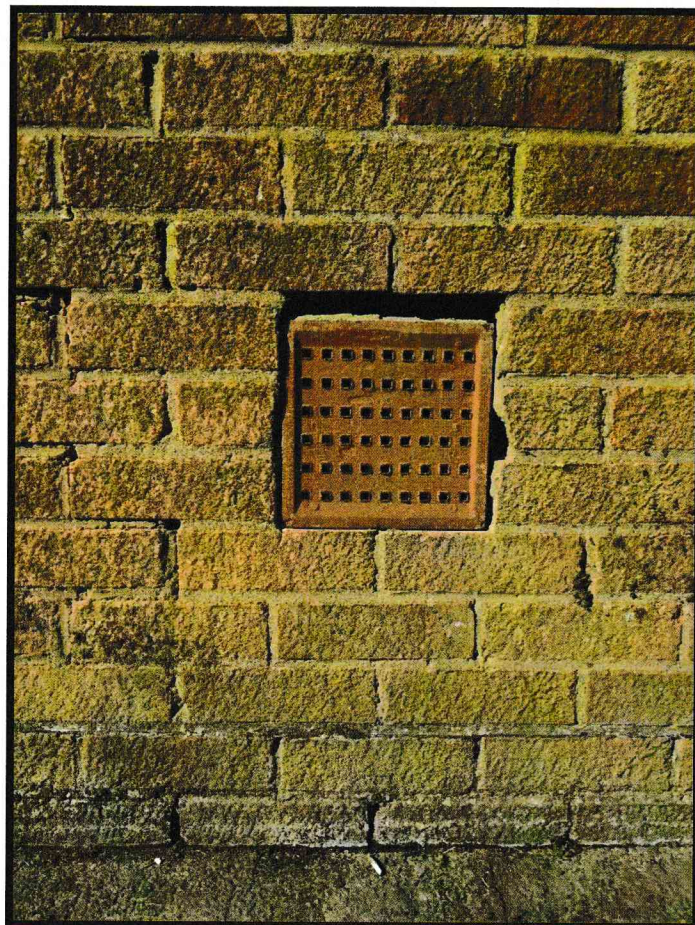
Fig. 22. Air brick requires pointing in

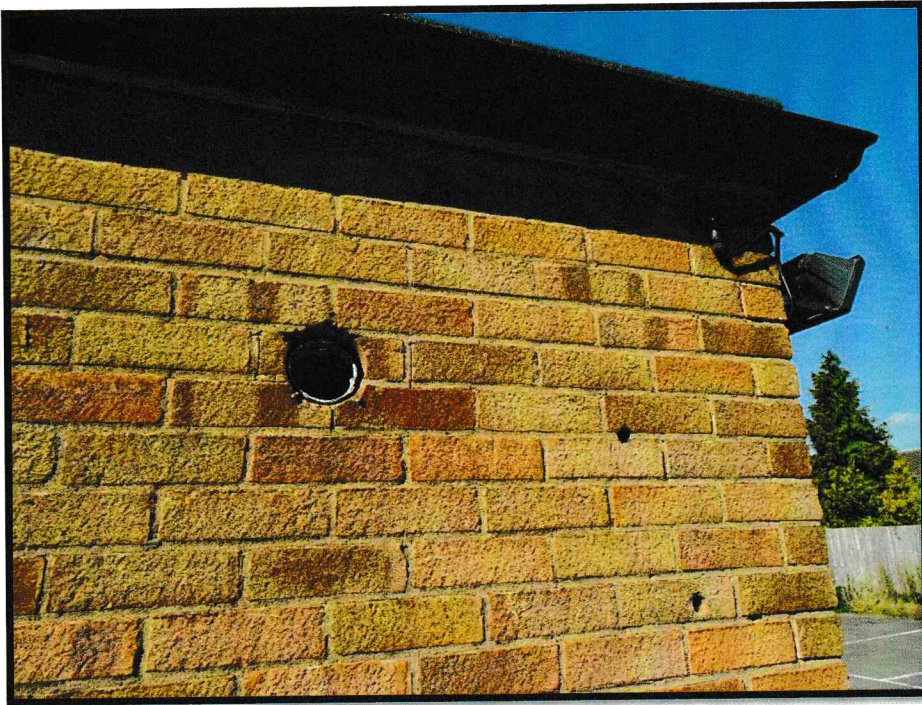
Fig. 23. Extract fan requires vent cover. Also note holes requiring filling.

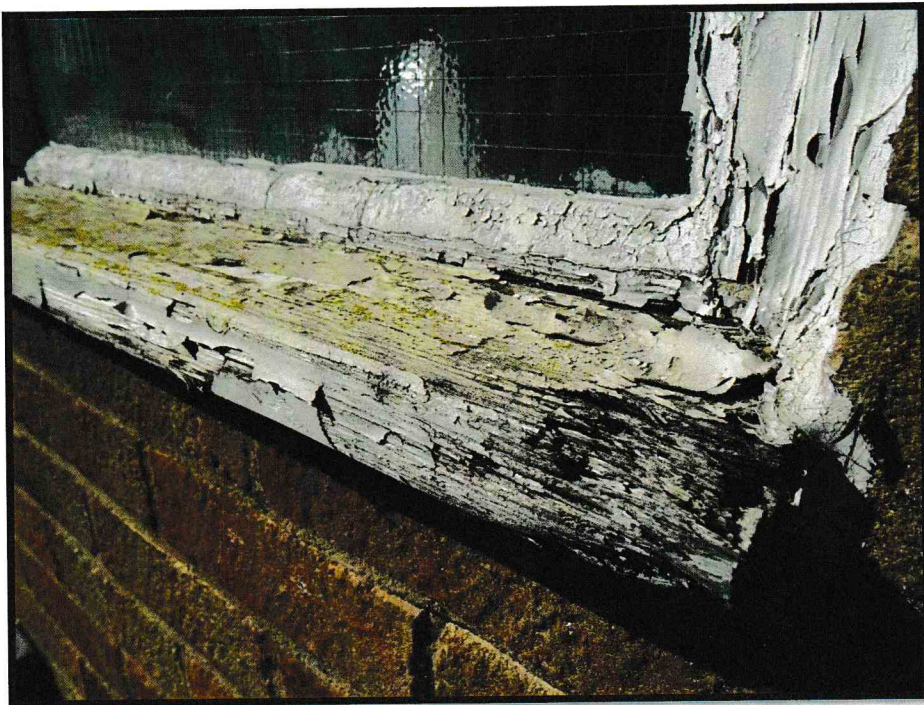
There are four timber frames, single glazed windows which are all in a dilapidated condition. Window cills have established rot, some sections of glazing bead are missing and the painted decoration is peeling throughout (fig. 24).

Fig. 24. Rotten external timber window frame and cill

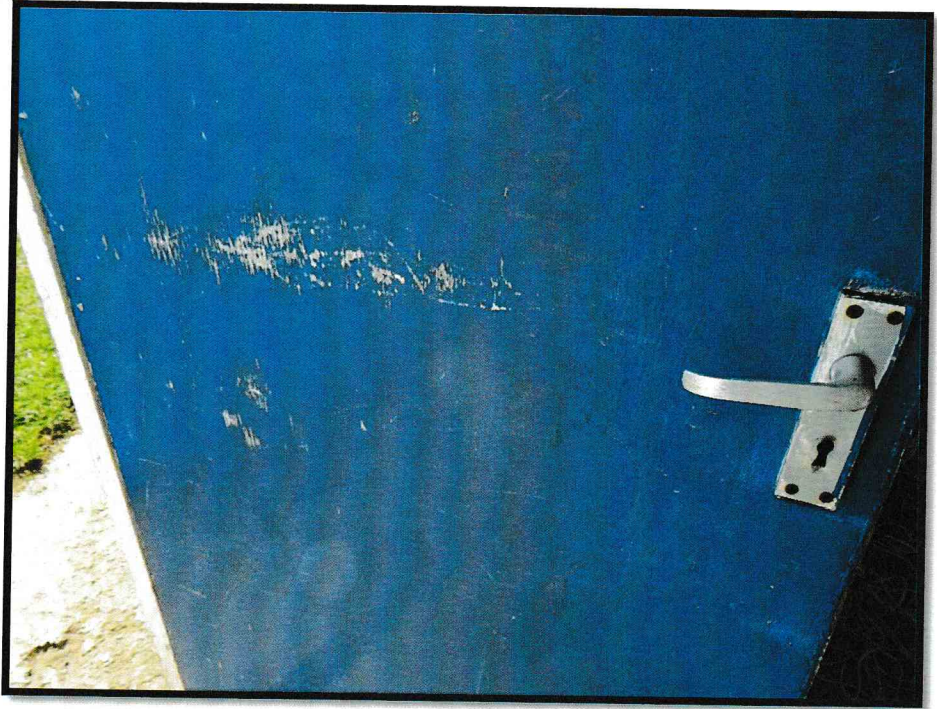
There are two flush timber doors set into timber frames. The doors themselves require redecoration and the ironmongery is worn (fig. 25). The left hand door frame shows signs of movement and also previous repair. Painted finishes to the frames are worn and peeling.

There is a single solid core, flush painted door leading from the outside. The door requires redecoration and the ironmongery is worn (fig. 25). There is a timber threshold which is worn (fig. 26). Paint is peeling from the external door frame, the mastic seal to the masonry has split and there is evidence of a previous repair at the base.

Fig. 25. Changing room doors require redecoration and replacement ironmongery

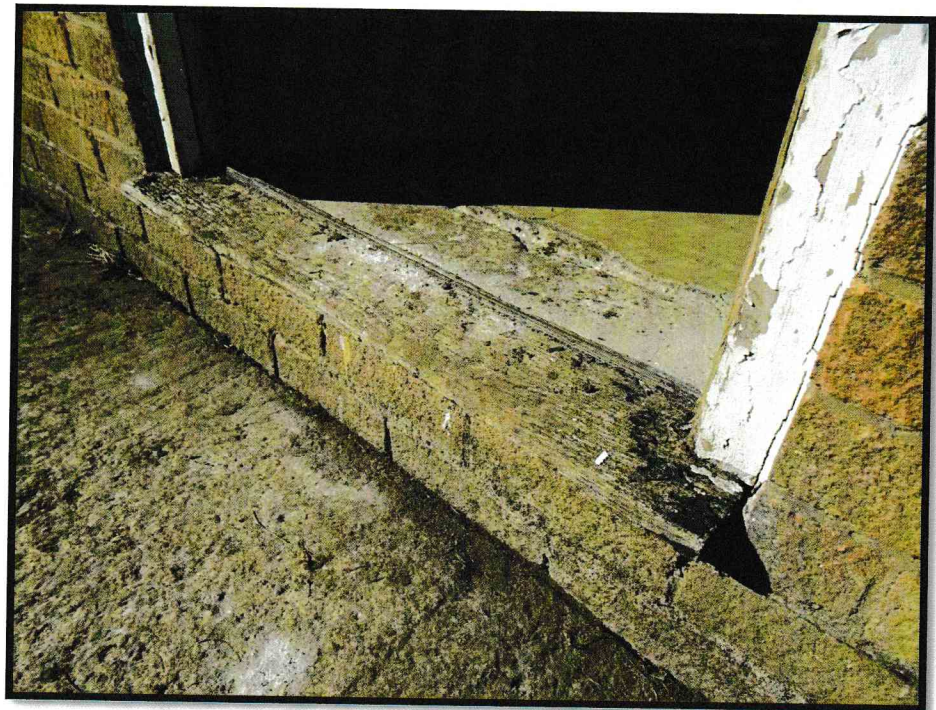
The doors feature timber thresholds which are also very worn (fig. 26).

Fig. 26. External timber threshold and door frame are worn.

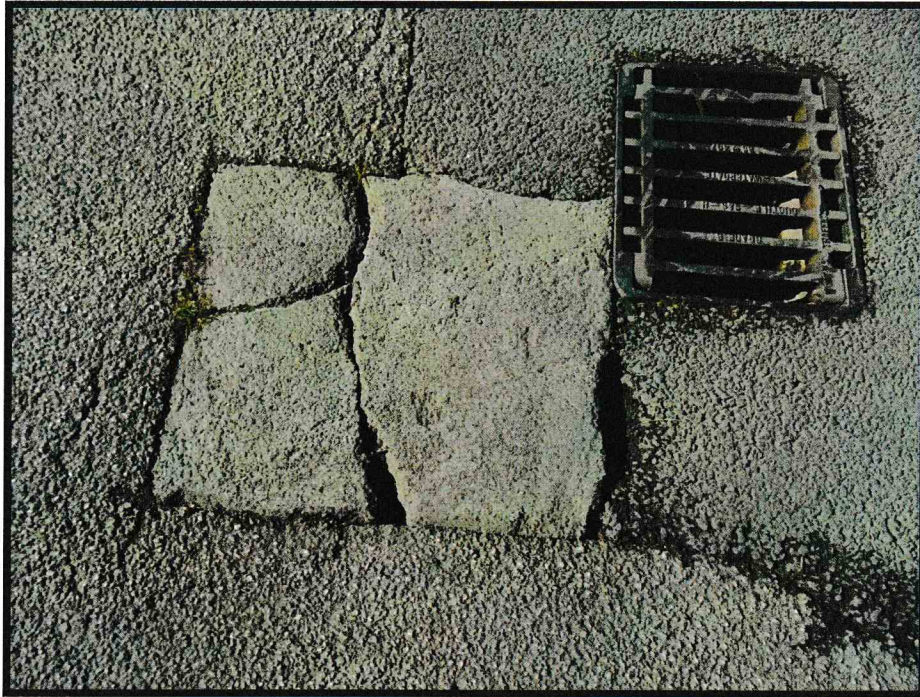
The tarmacadam and space markings to the car park are in good order, there are a few areas where adaptations have been made for below ground works but these all appear even and level. One section adjacent to a road gully is loose (fig. 27) and should be monitored to ensure it does not break up and cause a trip hazard. In due course this section should be re-laid.

Fig. 27. Poorly filled section of car park surfacing

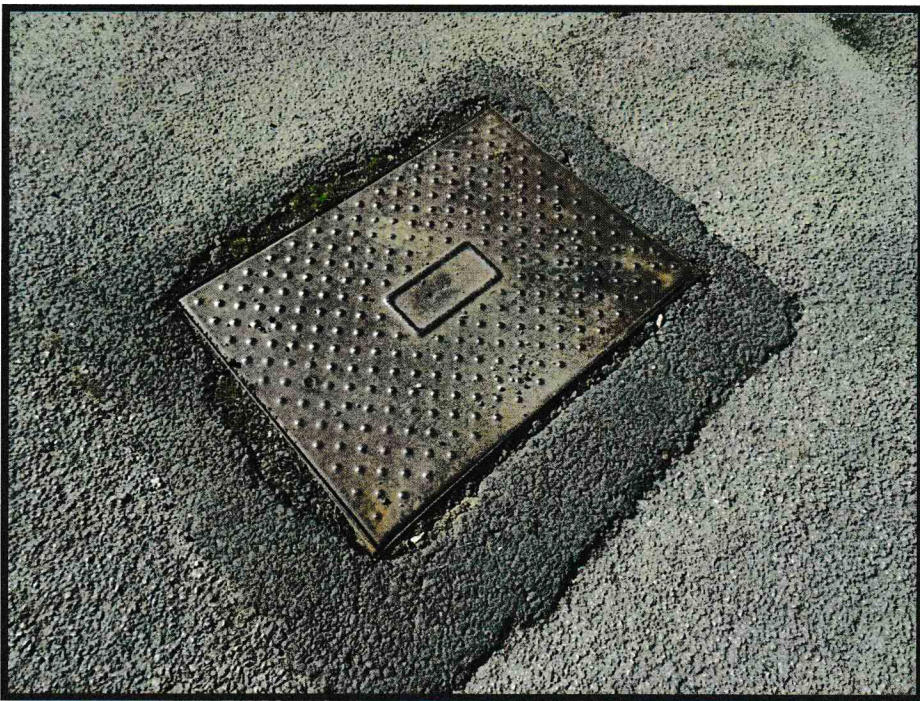
One manhole was noted as having a slightly bowed cover (fig. 28), the rating of the cover should be checked to ensure it is adequate for the traffic utilising the car park, if not, it should be replaced with a cover with a higher load rating.

Fig. 28. Manhole cover specification should be checked for strength

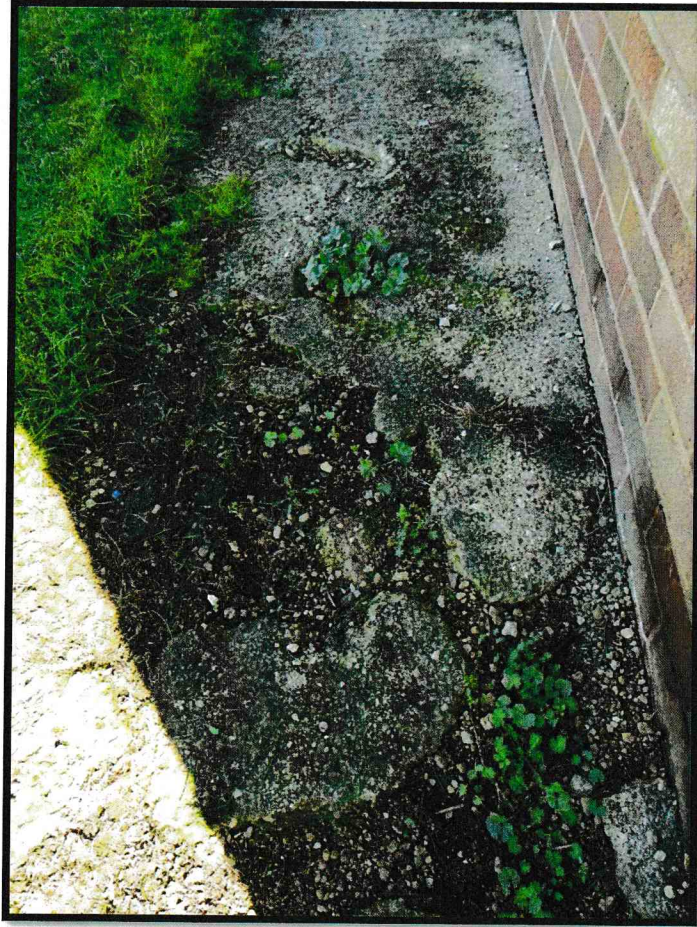
The concrete path to the side and rear of the hall has broken up in places (fig. 29).

Fig. 29. Concrete path around building is breaking up in places

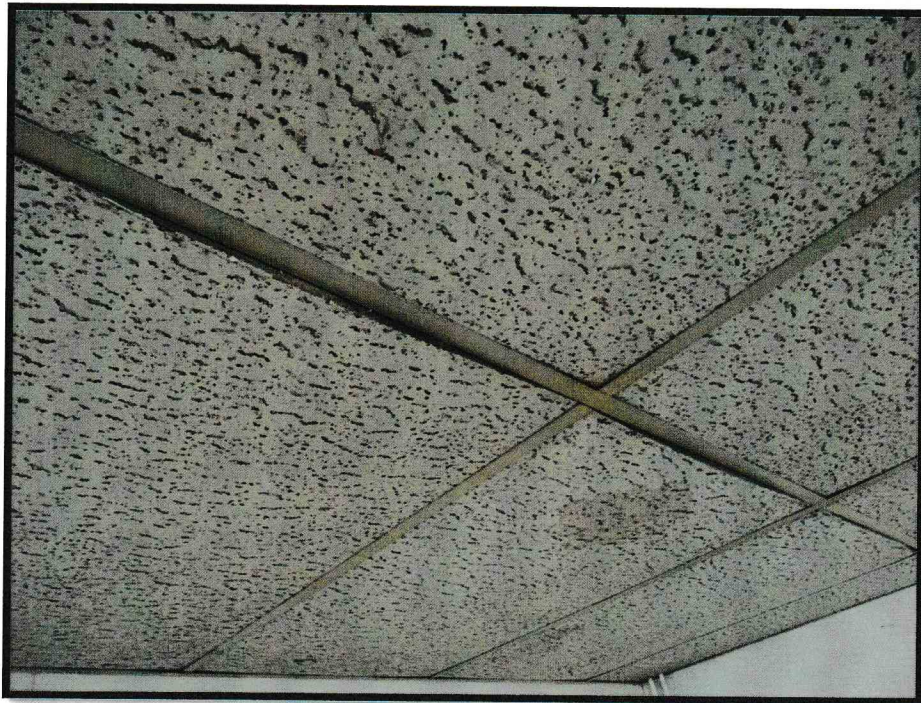
Fig. 30. The main hall suspended ceiling

The hall ceiling comprises a 600 x 1200mm suspended ceiling grid with inlaid tiles. The grid has discoloured with age and the tiles are beginning to sag. In a number of positions, the tiles are not sitting correctly in the grid and a number of tiles were damaged towards the stage end of the hall (fig. 30).

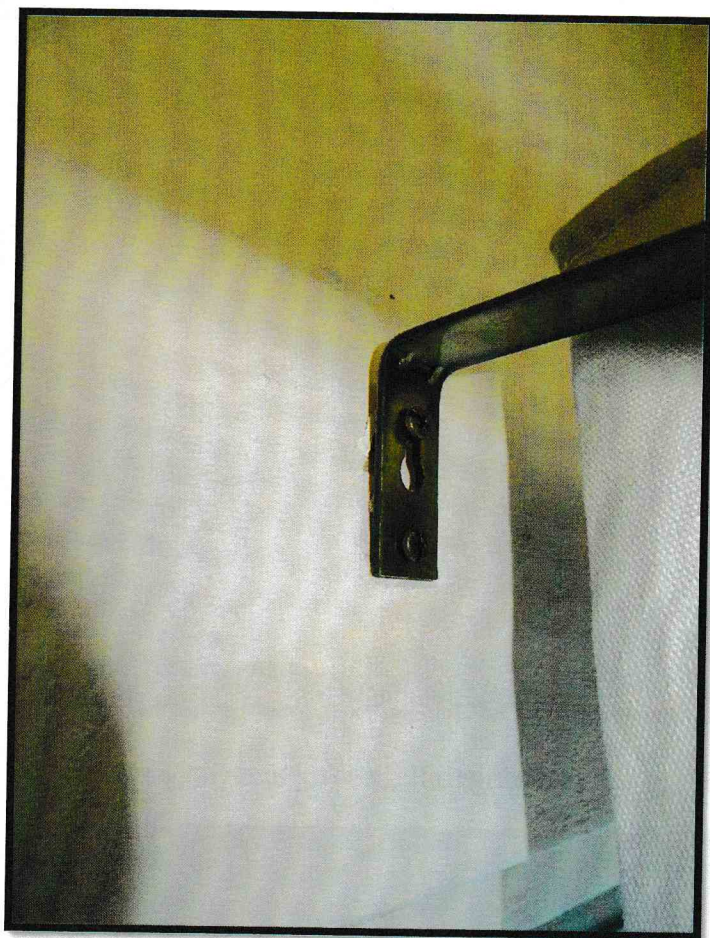
Fig. 31. Curtain rail fixing requires tightening

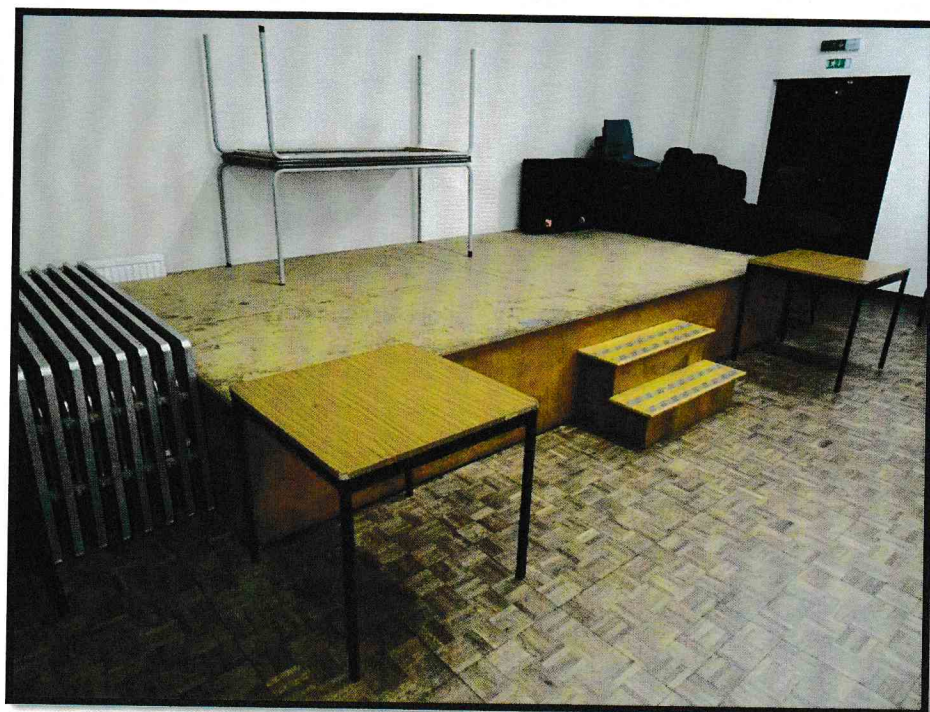
Fig. 32. The stage in the main hall

There is a timber stage area at the end of the hall, the steps were free standing. There are some signs of water staining to the surface (fig. 32) but all appeared to be in otherwise good condition. The structure beneath was not viewed.

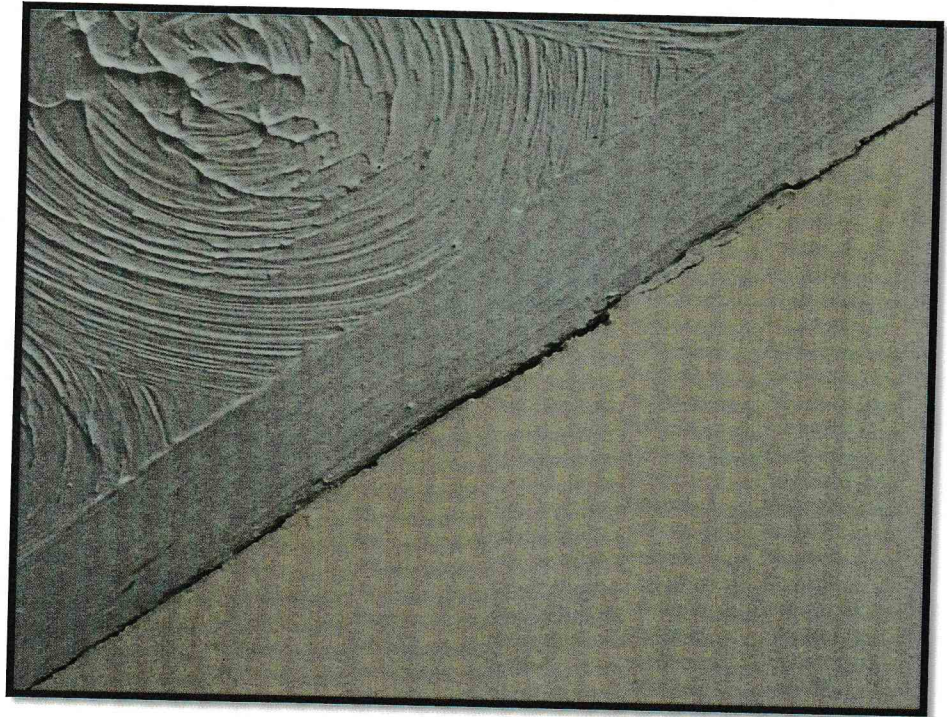
There are slight cracks to the side wall junctions (fig. 33).

Fig. 33. Cracking to the ceiling and wall junction

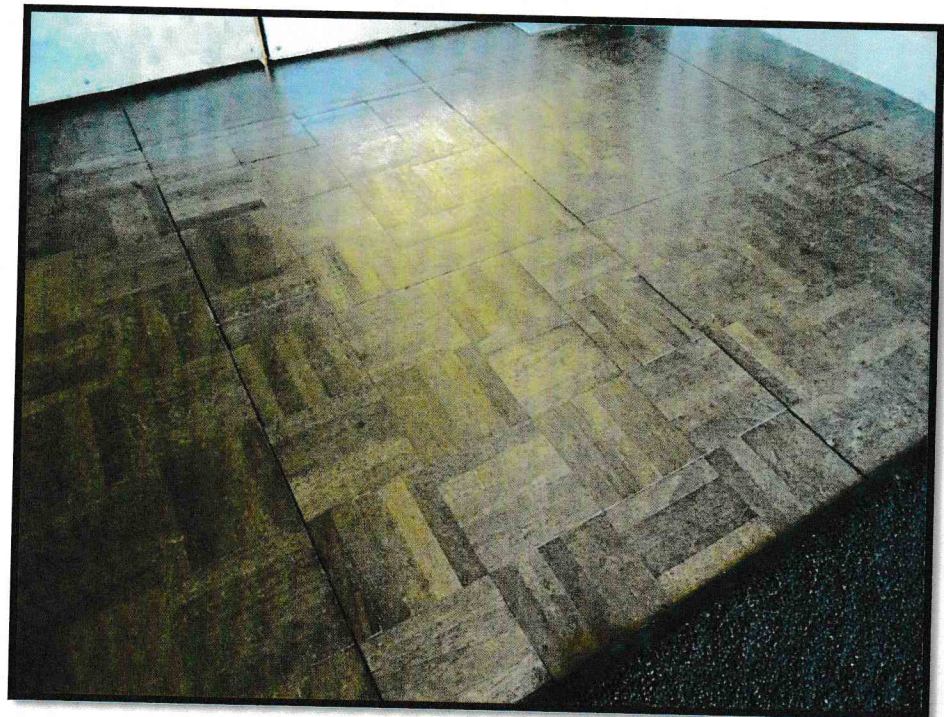
Fig. 34. The timber parquet flooring panels

The lobby features square timber parquet flooring panels. On tapping a number of panels it appeared that the adhesive may have de-bonded leaving some panels slightly loose (fig. 34). There are some slight cracks between the panels and the panels themselves would benefit from refurbishment.
