Longford Village Hall  
Longford Lane, Gloucester  
GL2 9EL

## Condition Report

20255/October 2016

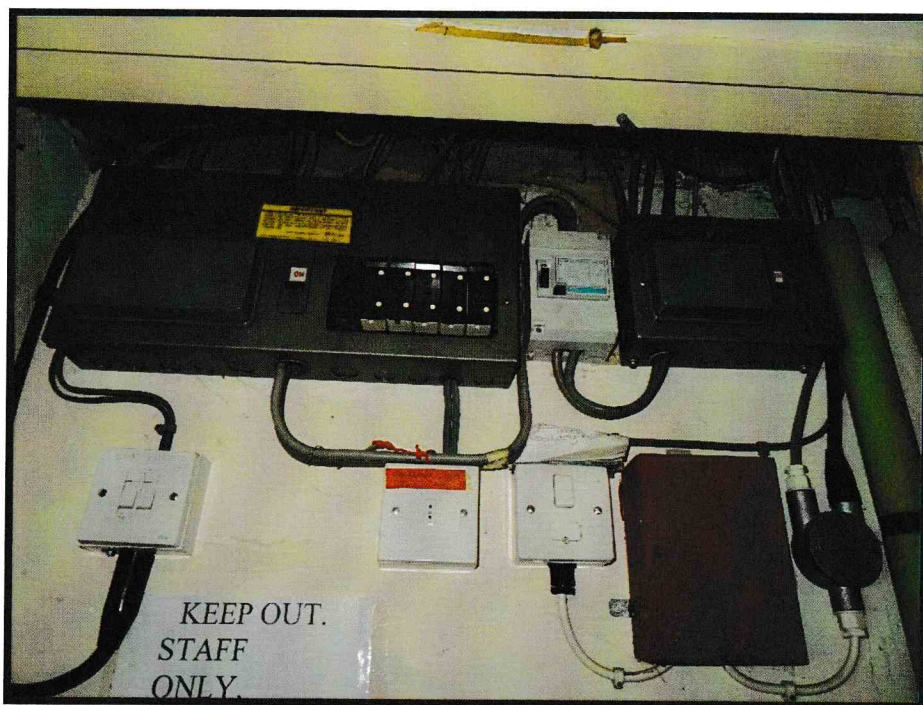
Fig. 35. The original electrical installation

Electrically, the fuse boards and accessories appeared to be the original fittings in places. The boards are now likely to be obsolete and will require replacement. Switches and the like are also showing signs of mechanical wear – No fixed wiring test was available.

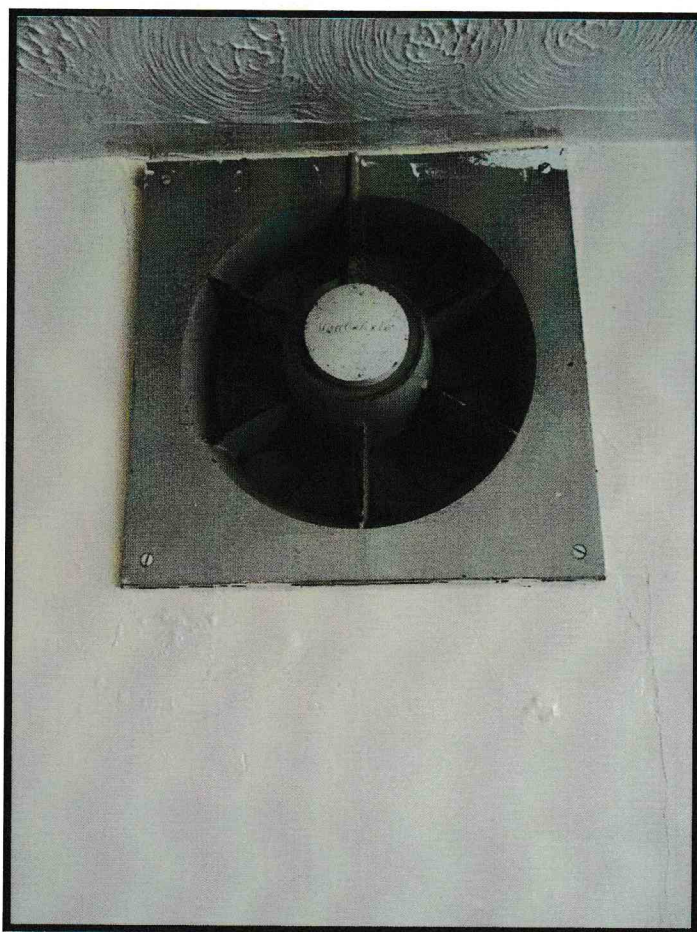
Walls feature a decorated plaster finish which is in good decorative order. Some minor hairline cracking was noted and there is a small area of damp evident below the kitchen extract fan (fig. 36).

Fig. 36. Kitchen extract fan, note minor damp evidence in the wall below

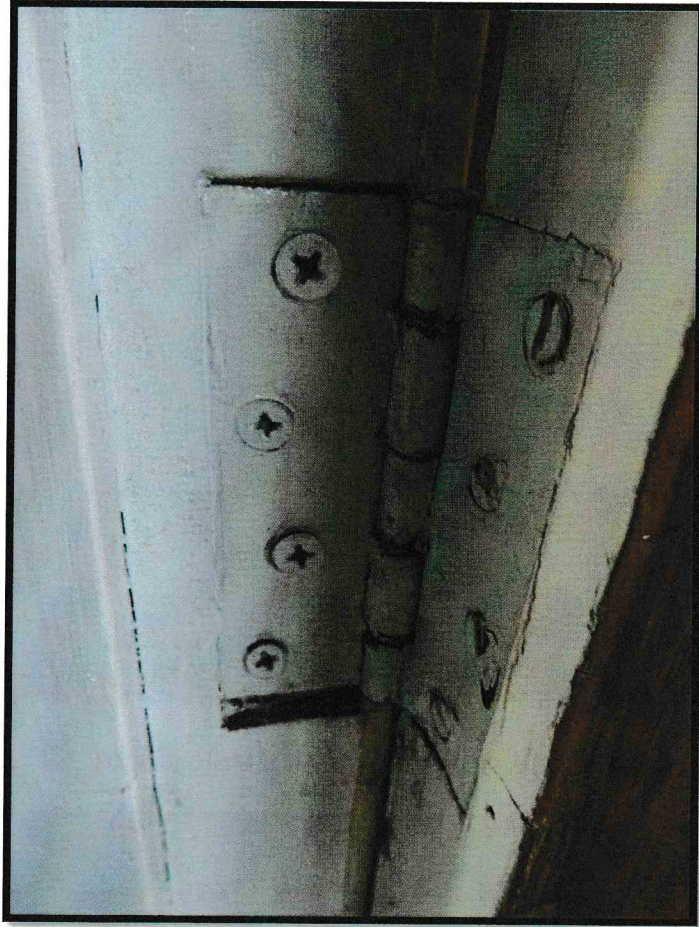
Fig. 37. Poorly fitting and aged kitchen door hinges

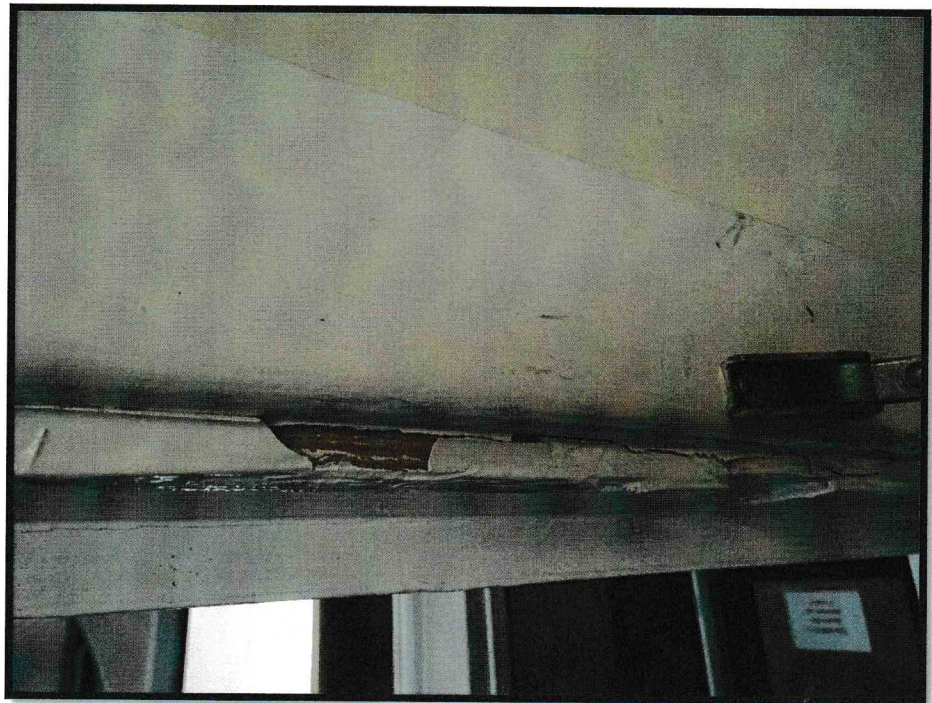
Fig. 38. Damage to the head of the kitchen door

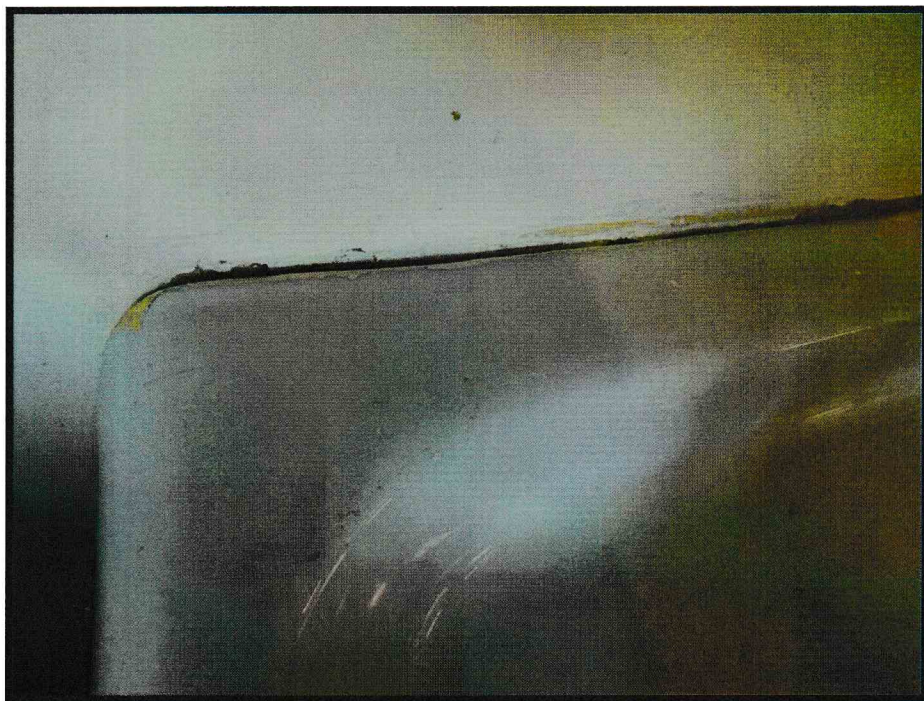
The wash hand basin is slightly loose on the wall and this has separated the mastic seal (fig. 39).

Fig. 39. Gap to the rear of the kitchen wash hand basin

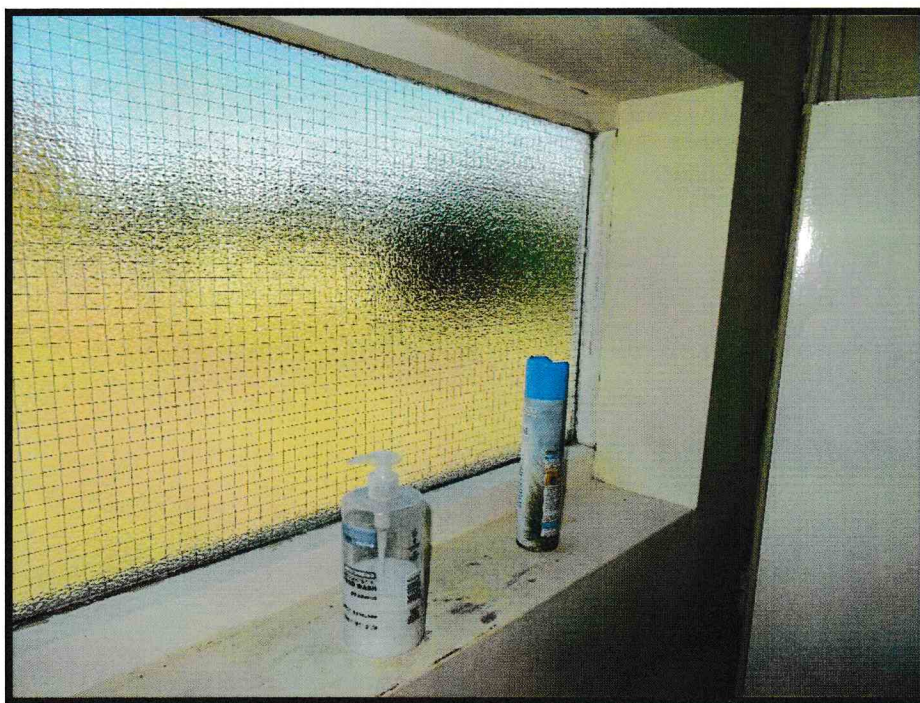
The walls are plastered with painted decoration and in good decorative order. The paint to the window cill is worn/peeling, possibly as a result of spilled soap and cleaning products on the cill (fig. 40).

Fig. 40. Dilapidated finishes to the ladies toilet window cill

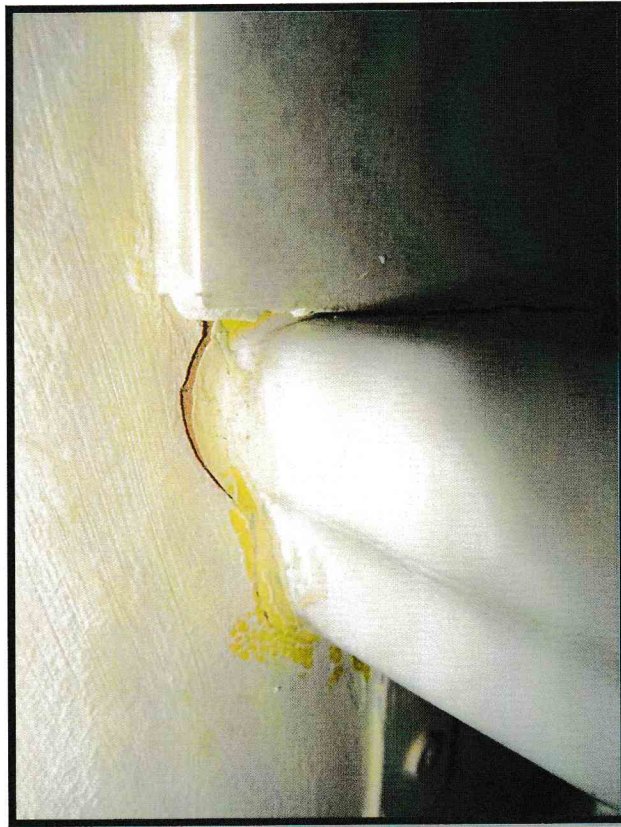
The wash hand basin is loose on its wall fixings (fig. 41)

Fig. 41. The basin in the ladies toilet which is loose on the wall

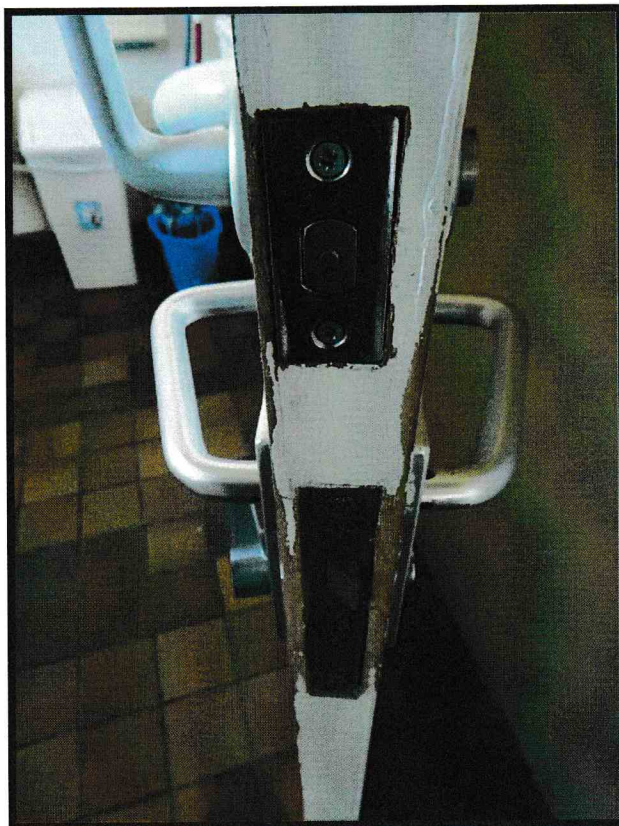
Fig. 42. The disabled door edge

There is a flush timber door which is in reasonable condition. The door edge is worn, the handle is also worn and the bottom latch does not operate (fig. 42). The strike plate has been replaced at some point with one of a different size and this has left the frame looking untidy (fig. 43).

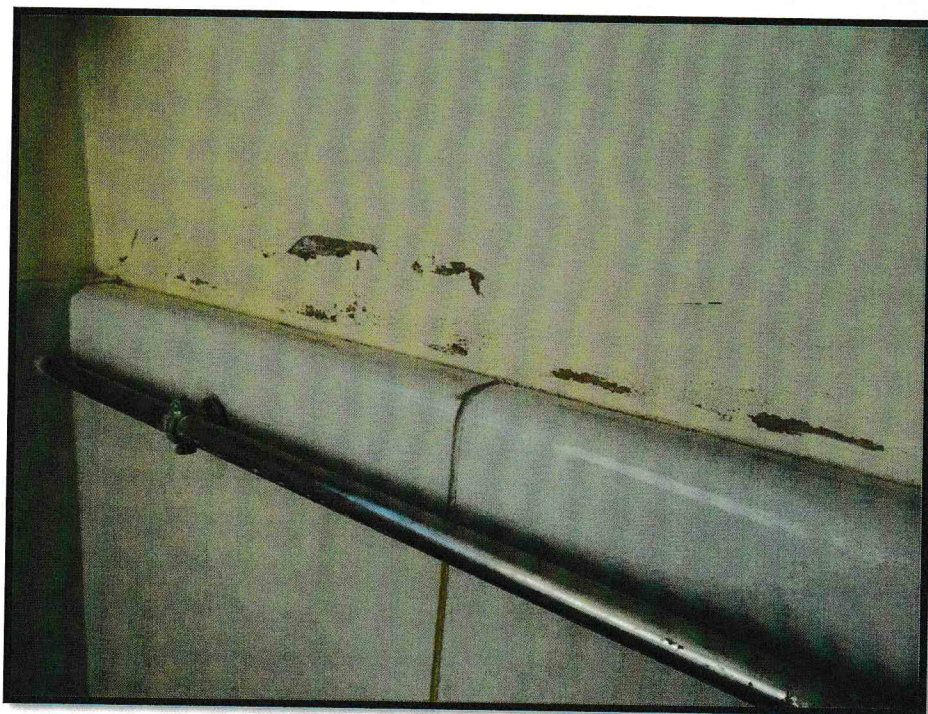
The walls are all plastered, there is some slight wear above the urinal trough (fig. 44) and there is also a hairline crack above the window lintel position.

Fig.44. Wear to the finishes above the urinal in the gents toilets

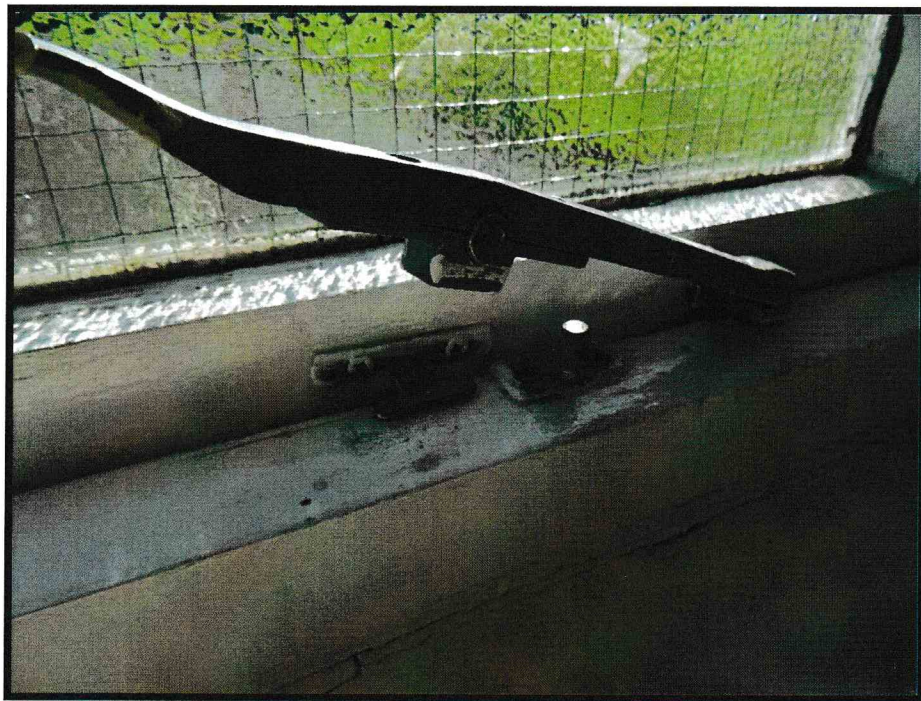
There is a timber framed window, the stays are loose (fig. 45) and there was a crack to the cill. The window itself is in reasonable order internally.

Fig. 45. Inoperative lock to the window in the gents toilets

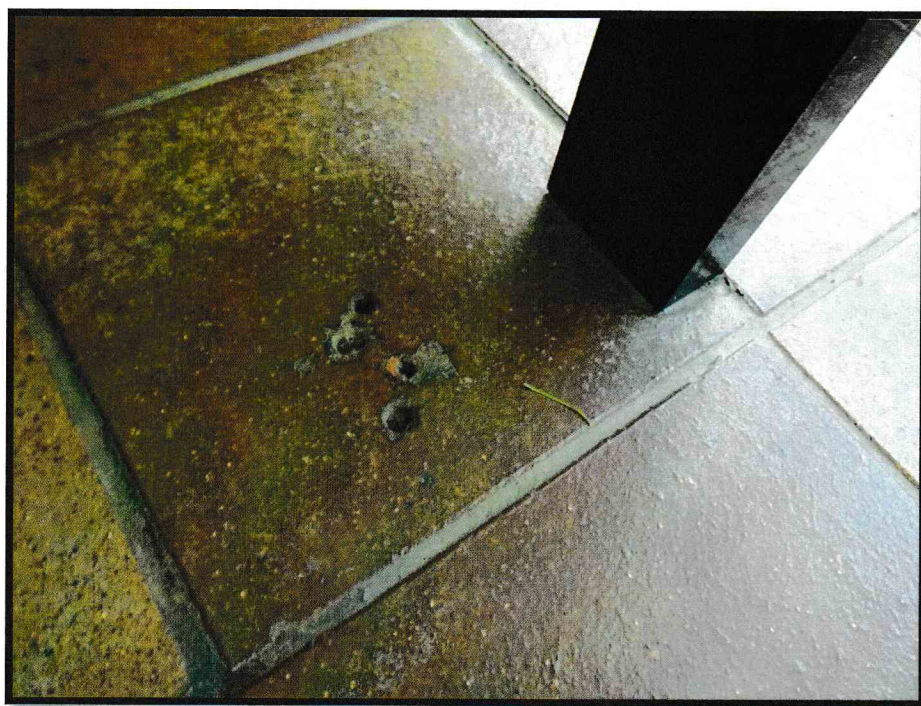
Fig. 46. Redundant fixing holes in the quarry tiled floor

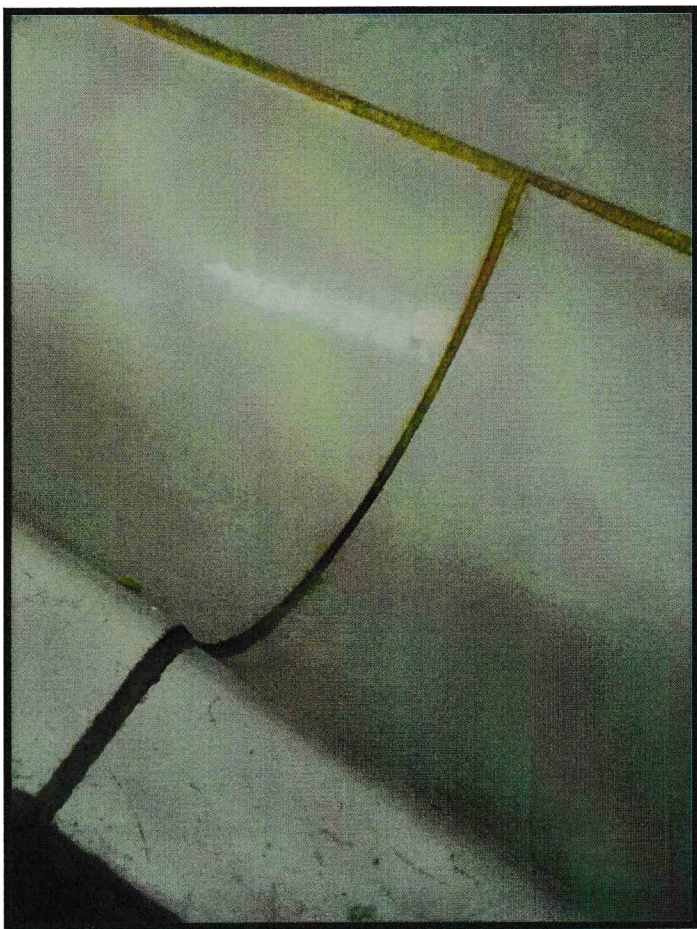
The trough urinal is in good order, the grout has discoloured and the grout joints to the trough sections requires renewal (fig. 47). The urinal is connected to a black cistern which has some slight corner damage. The cistern should be tested for asbestos content as part of any future asbestos survey.

Fig. 47. Dilapidated grouting to the urinal trough

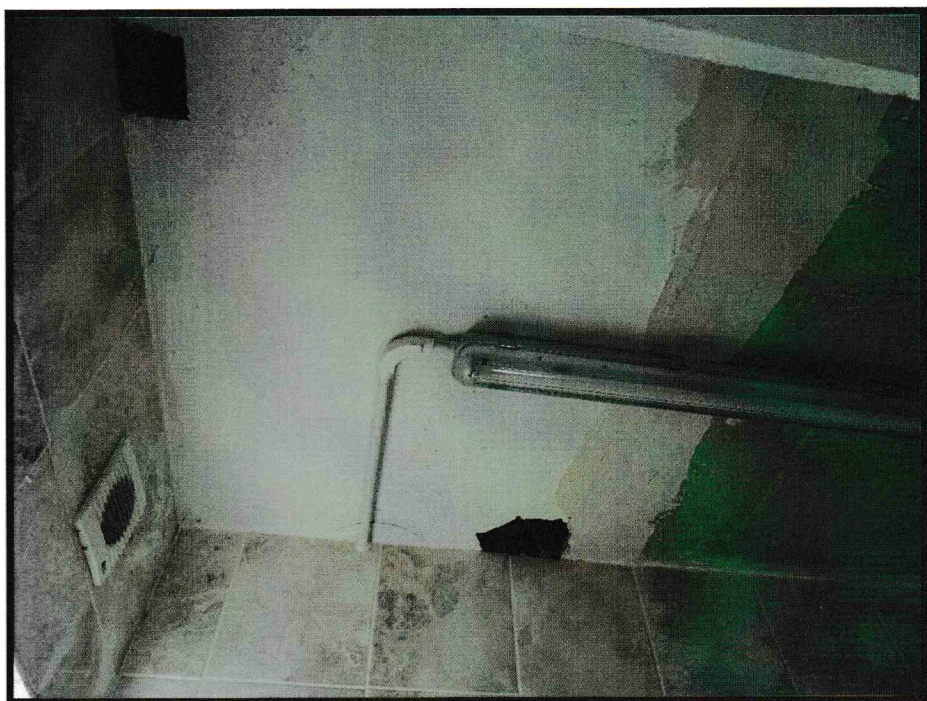
Fig. 48. The shower area ceiling

The ceiling is plastered, the changing room areas are in good condition although the shower area ceiling is damaged and requires attention (fig. 48).

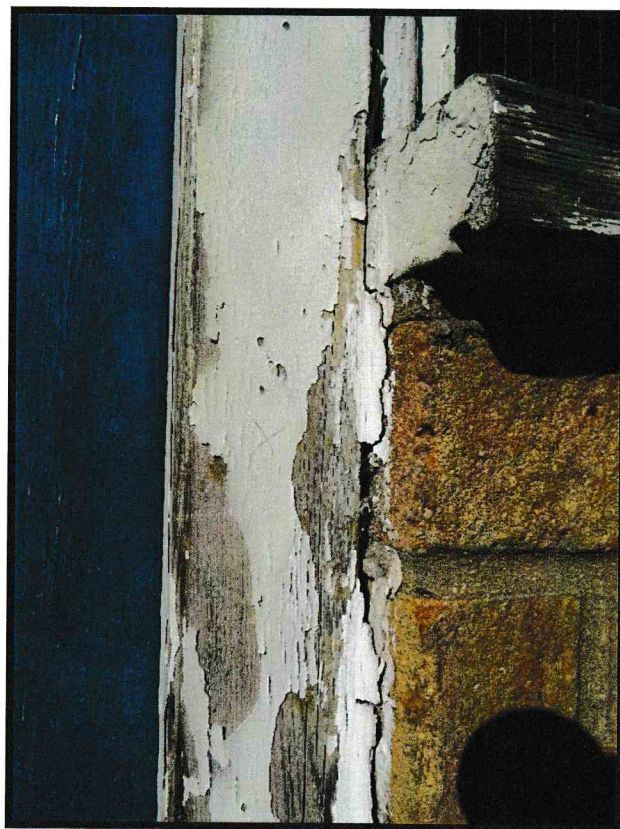
Fig. 50. Changing room external door frames are dilapidated

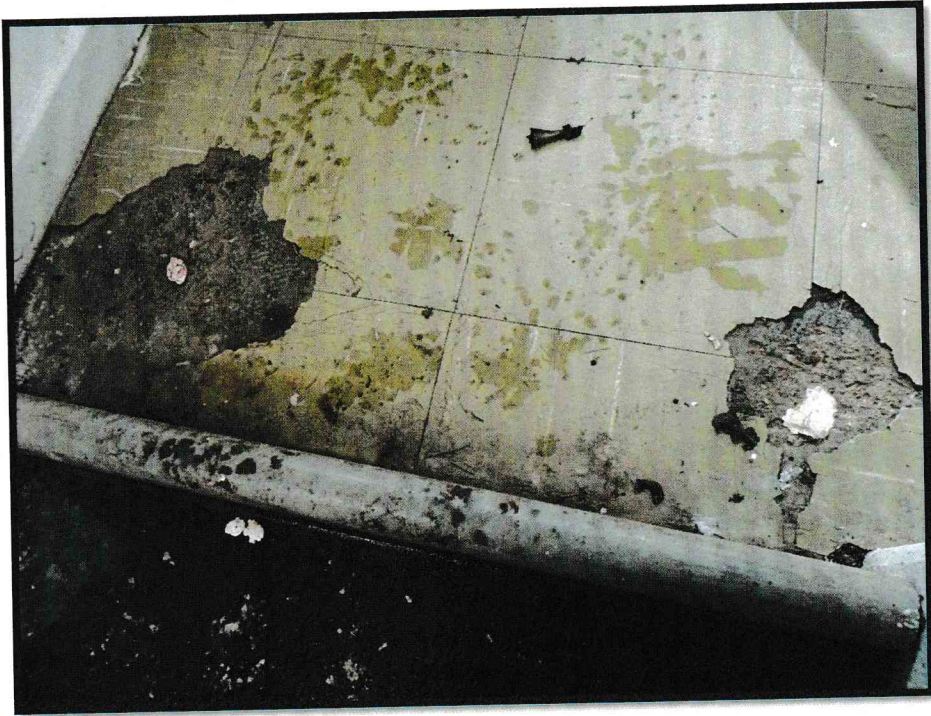
Vinyl floor tiles are laid throughout the changing room. There is damage adjacent to the doors and showers. The tiles should be tested for asbestos content as part of any future asbestos survey.

Fig. 51. Damaged vinyl floor tiles in the changing rooms.

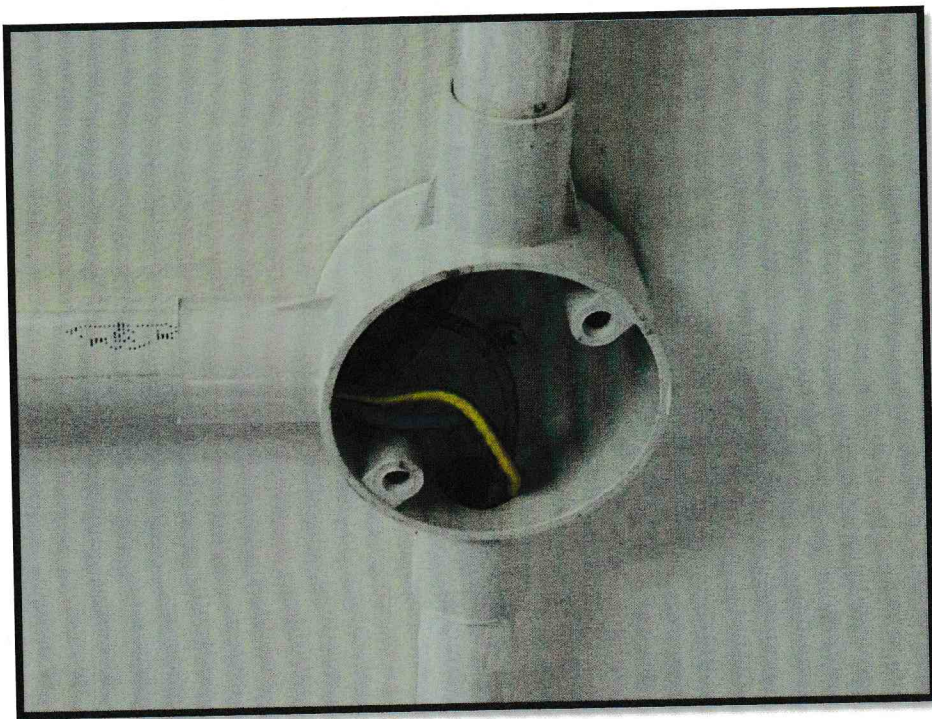
Fig. 52. Missing conduit junction covers in the changing room.
